Repairing Lightning Strike Damage

Executing rope-access blade repairs at a UK offshore wind farm

Conaill Soraghan and Sally Shenton | January 2018 | CS-0019

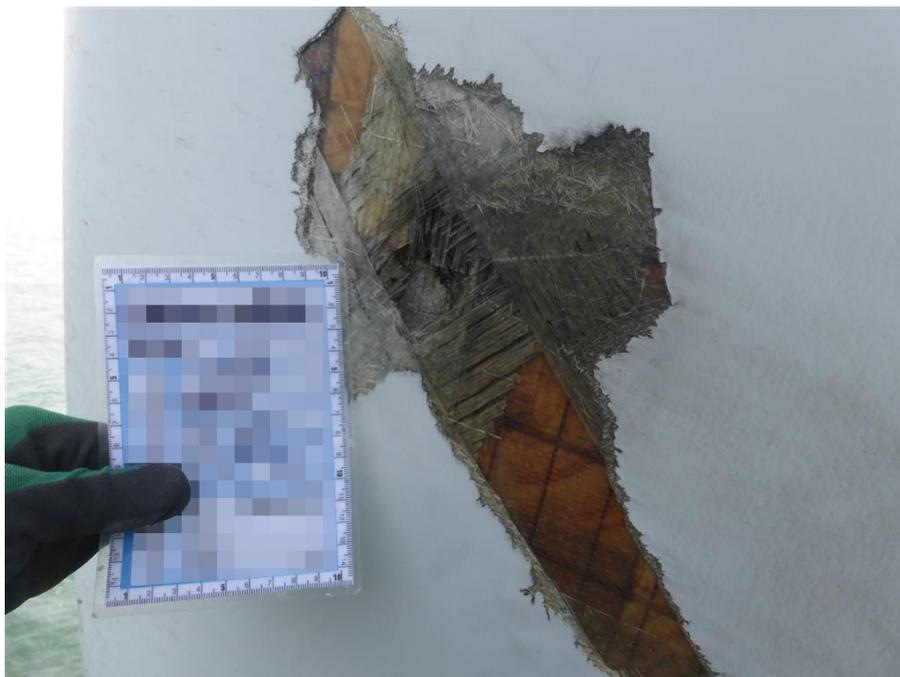
Across all the blades in the wind farm, the inspection identified a range of issues. This included damage such as marks on the top coat, leading edge erosion and cracks. Of all the blade maintenance that was recommended, the Owner/Operator originally identified three blades that required immediate attention, each of which had suffered lightning strike damage. One of the lightning strike damage images from the inspection is reproduced in Figure 2. It can be seen that lightning has burned a hole in the fibreglass structure. Such damage is a structural integrity concern that may require the turbine to be stopped. This introduced a risk of lost production for the approaching winter and hence, the owners were keen to carry out repairs quickly.

Figure 2: Lightning strike damage identified on a blade at the offshore wind farm

The only feasible solution available to the Owner/Operator for repairing the hole in the blade structure was to use a rope-access team to work at heights on the blade in-situ and expose the damaged section, before relaying the necessary fibreglass. In five years of operational experience at the offshore wind farm, neither the Owner/Operator nor the OEM had completed a rope-access blade repair.

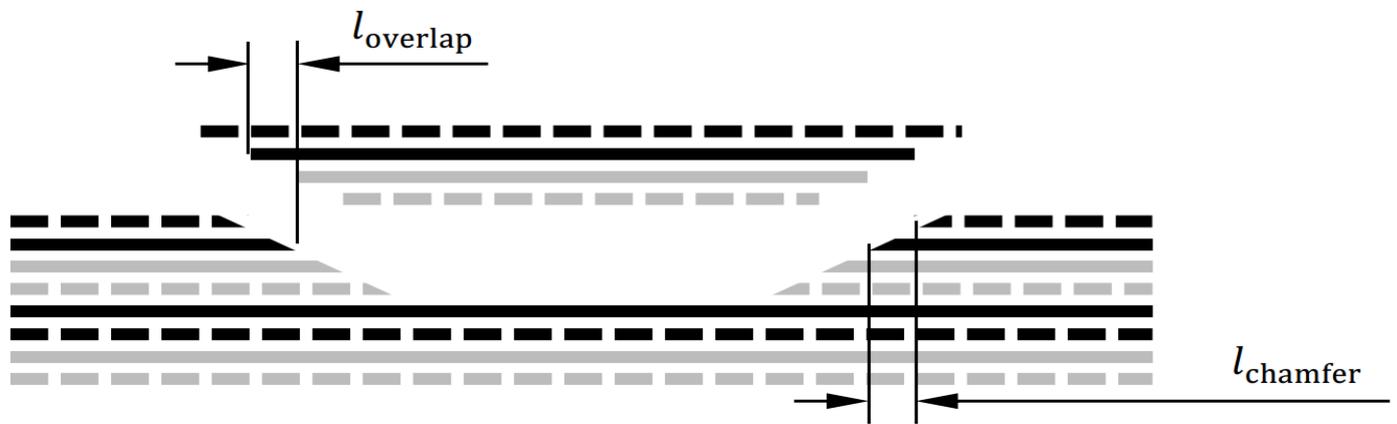
Figure 3: Laminate repair method as described in the DNV-GL guideline^[1]. The solid and dotted lines represent different material types – in this case, balsa wood and laminate layers.

Firstly, the full extent of the damaged balsa would be replaced, then the layers of fibreglass in the outer section would be laid at a gradient to increase the surface area of the interface between the original and new fibreglass layers. This allows the new layers to bond effectively.

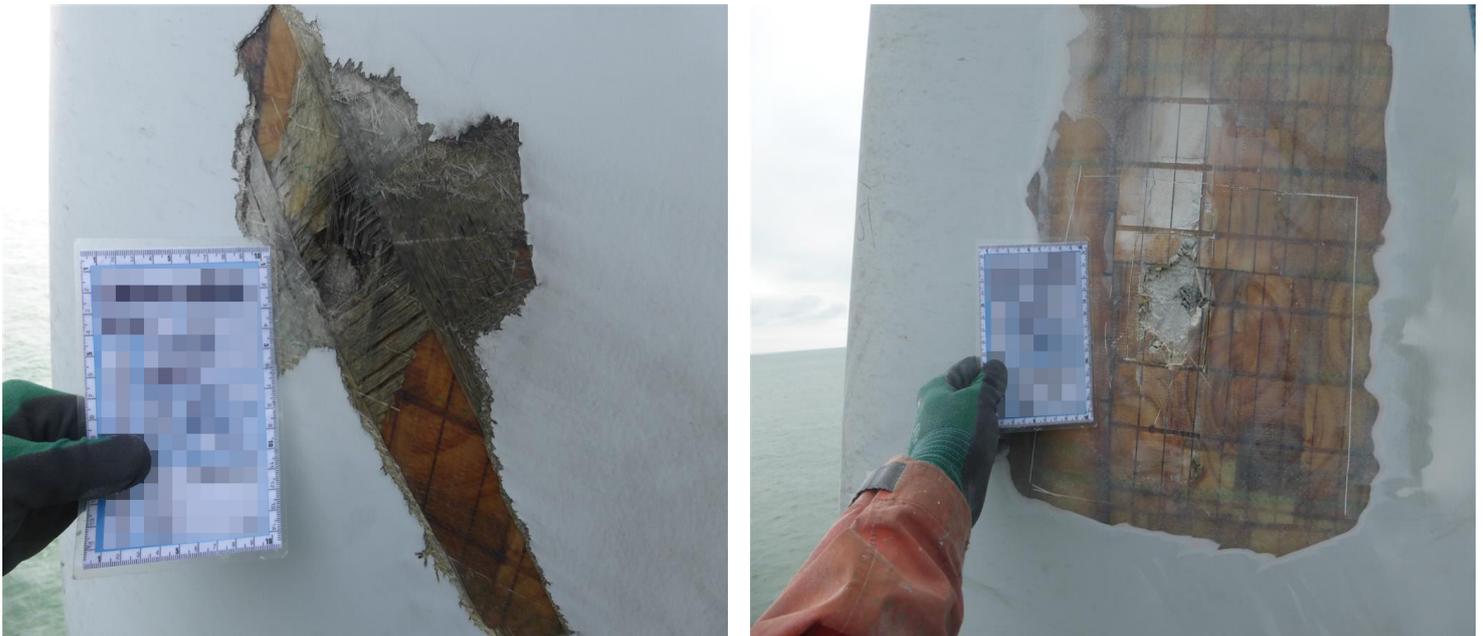
Figure 4a and 4b

The first blade repaired was D10 and this work began on 5th September 2016. The damage as found on arrival is shown in Figure 4a. Once the damaged area was prepared for work, it was clear that many layers of the blade structure were affected, as seen in Figure 4b.

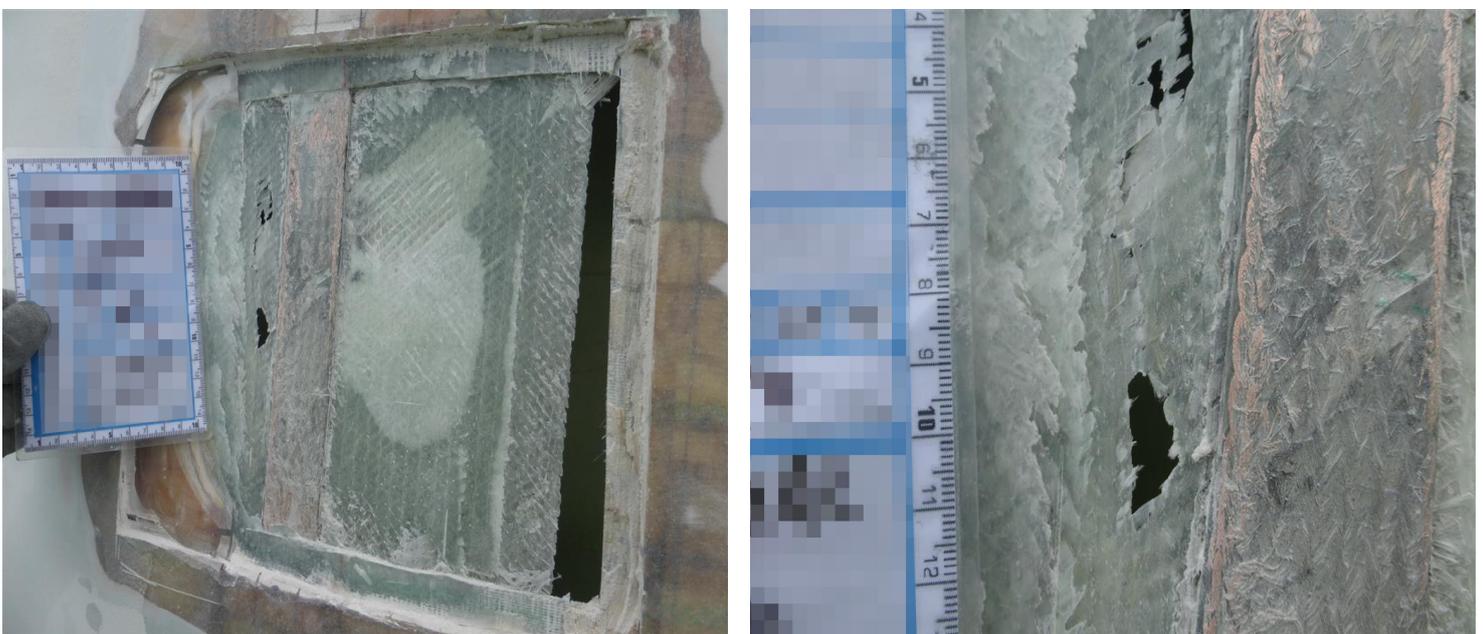
Figure 5a and 5b

The full extent of the damage became clear only after the technicians began removing the wet balsa wood core. Figure 5a shows the extent of the balsa that had to be removed and Figure 5b shows that the lightning had burned a hole all the way through the sandwich structure, exposing the hollow centre of the blade.

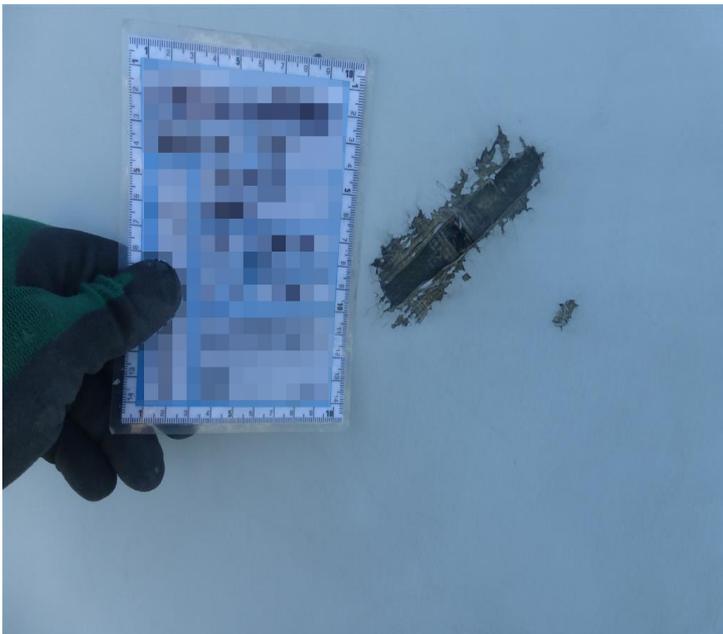
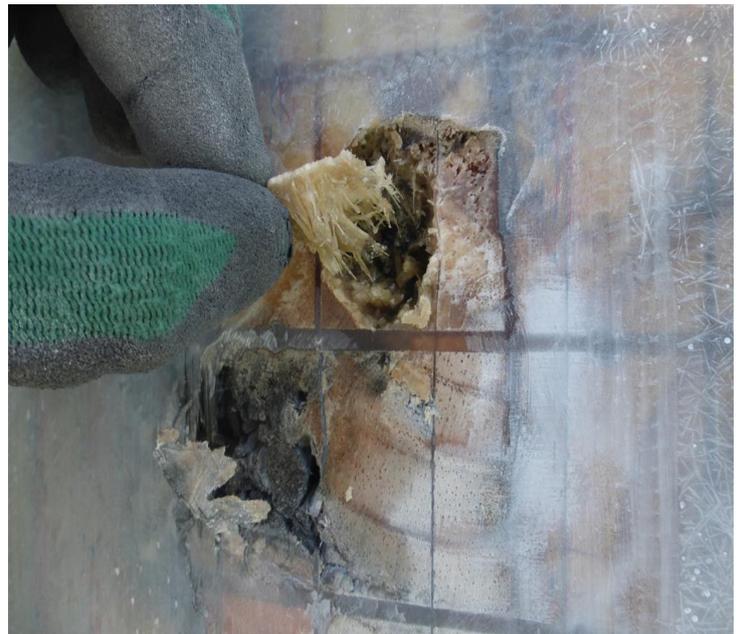
Figure 8a and 8b

Following completion of the D10 repair on 13th September, work started on blade E11 the next day. The damage as found on inspection was a relatively small burned hole as shown in Figure 8a. As the extent of the damage was exposed, it was clear that the balsa wood core was extremely wet and the engineer was able to pull away significant sections of rotten wood as shown in Figure 8b.

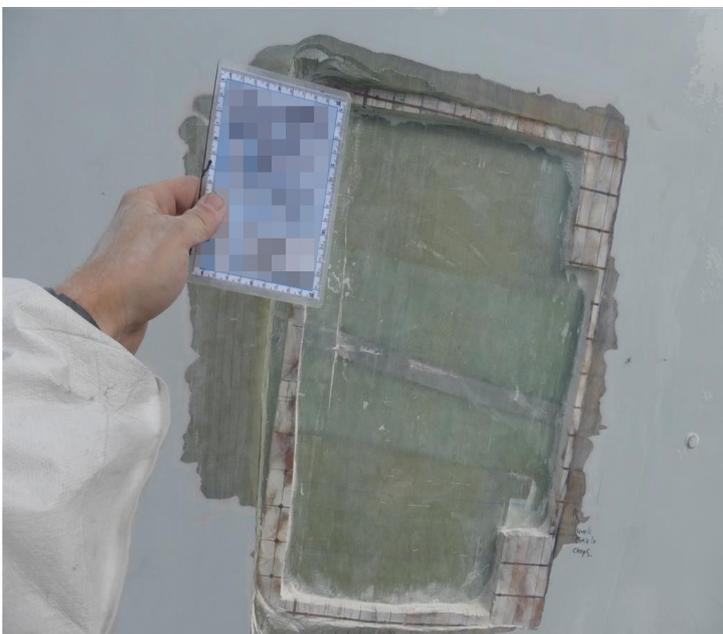
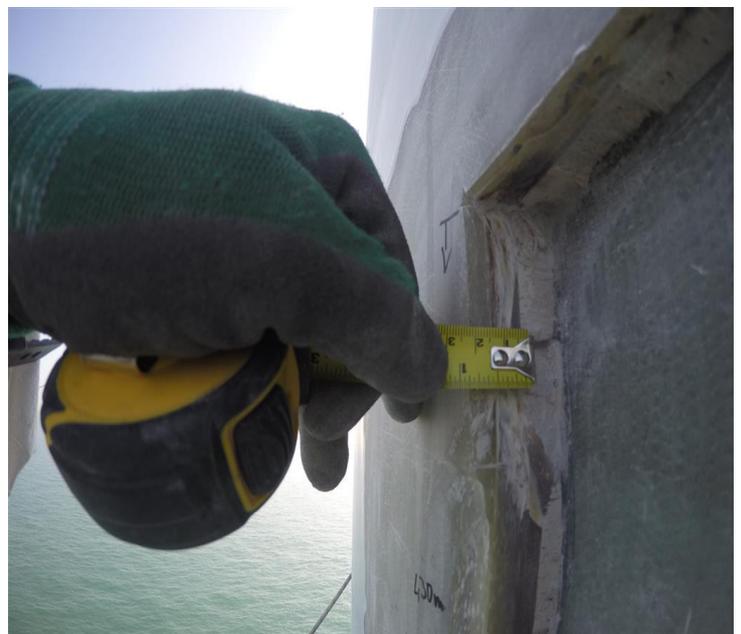
Figure 9a and 9b

The full extent of the area where wet balsa wood had to be removed is shown in Figure 9a. The depth of the incision into the blade is shown in Figure 9b.
