Owner-Led Offshore Wind Gearbox Replacement

Equinor's strategy at Sheringham Shoal

Dr Conaill Soraghan and Sally Shenton | June 2018 | CS-0020

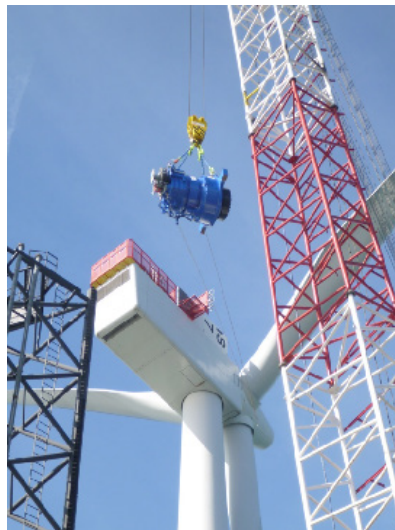
Figure 3: Change-out of a Winergy gearbox at Sheringham Shoal in Q1 2015

The procedure involved supporting the gearbox while technicians unbolted it from the main shaft. Most of the necessary lifting tools were available in the market, but the wind farm's operator had to manufacture some specialised instruments. The sea fastenings were provided with the two gearboxes purchased from Siemens.

All work instructions and procedures were fit for purpose and the change out of both gearboxes took 10 days.

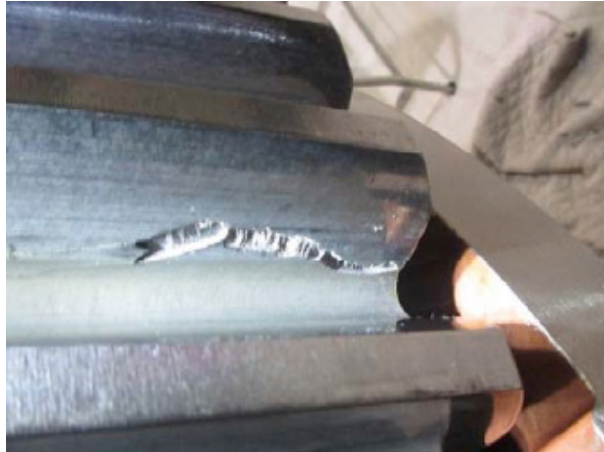
Moventas stripped down each gearbox to its constituent parts in order to carry out RCA on each gearbox. It was concluded that both gearboxes had suffered from the same failure mode. Material defects were found within the planetary wheels in the first stage of the gearbox.

The gearbox that was inspected first in the field was significantly more damaged, with a crack running almost the entire length of the planetary wheel tooth. At one end of the tooth, the crack had developed into a fracture as shown in Figure 6.

Figure 6: Planet gear 3. Flank of sun pinion mesh. Fractured tooth. Rotor side end.

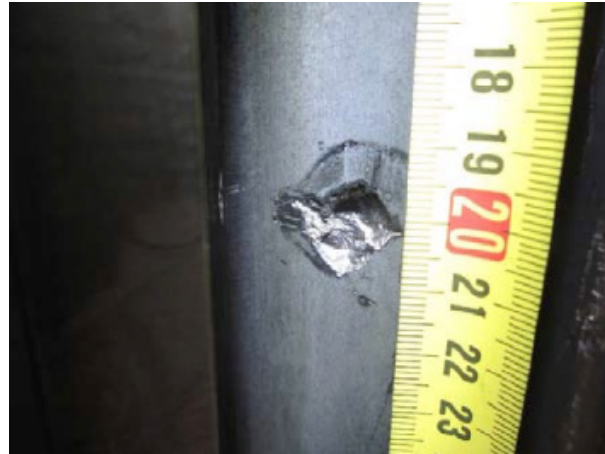
The damage on the second gearbox was more localised. A hole approximately 2cm in diameter had formed in a planetary wheel tooth as shown in Figure 7. This can occur when debris is trapped within the gearbox.

Figure 7: Ring gear (first stage): severe indentation
