Management of Hydrogen Sulphide (H₂S) Gas in Wind Turbine Sub-Structures: identifying and managing H₂S

TLI-CS-00006

In November 2013, elevated levels of the gas hydrogen sulphide were detected within the foundations of some of the wind turbines at the Teesside offshore wind farm.

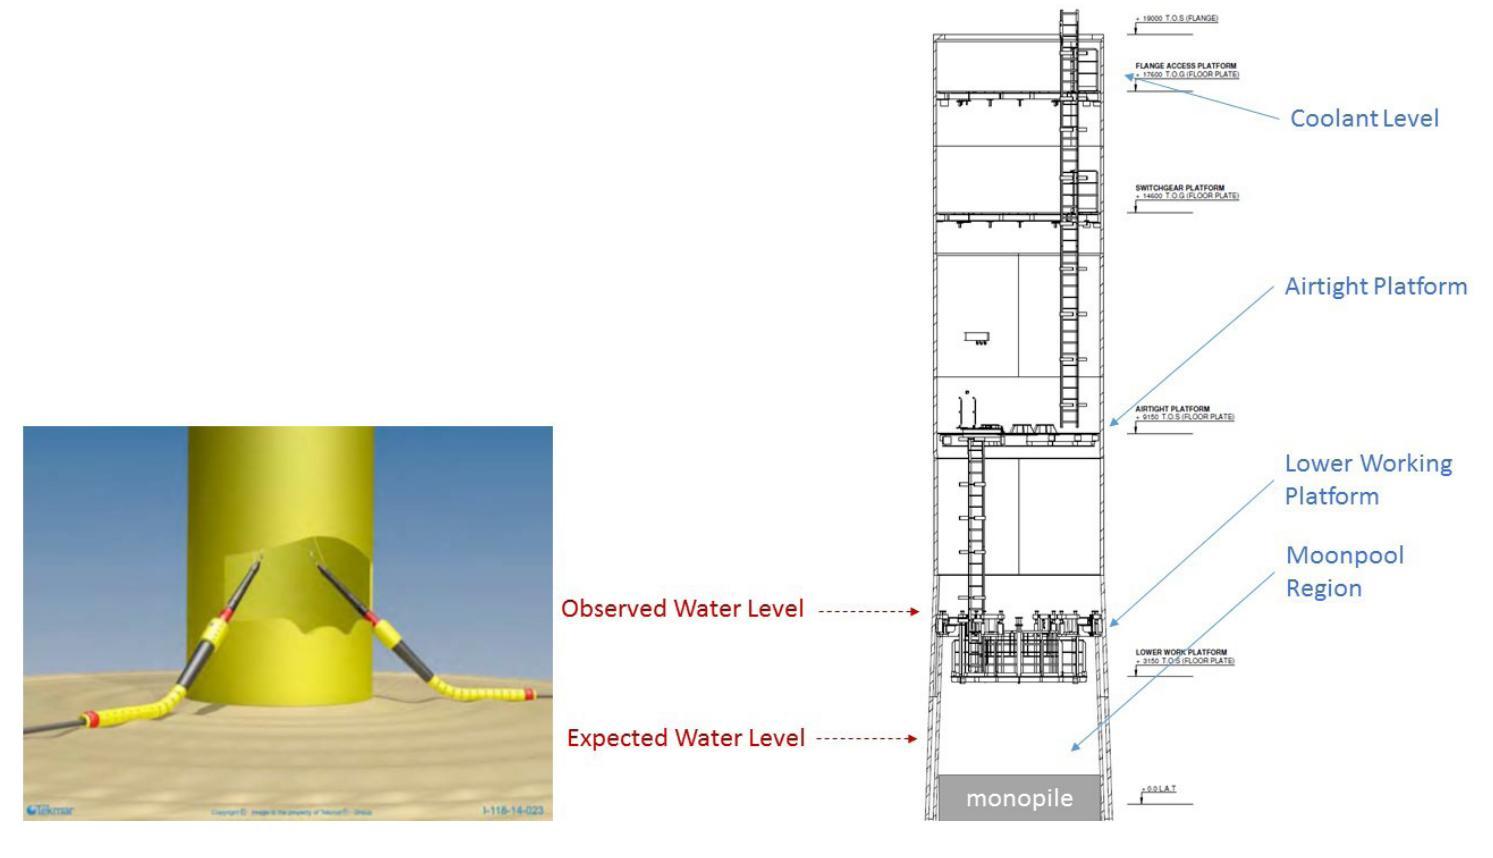
Figure 3: Tekmar seal design for cable entry and the compartments within the transition piece

Figure 3 illustrates the Tekmar seal and also shows the compartments within the transition piece. As part of this foundation design, it was anticipated that sea water would enter into the monopile area and below the lower working platform, known as the moonpool. In order to mitigate the corrosive impacts of sea water on the internal surfaces of the foundation structure, cathodic protection was implemented with sacrificial anodes attached to the internal surface of the moonpool. However, a complex reaction can occur between sulphur-containing microbes found in the sea and the cathodic protection system, which creates H₂S gas as a by-product.

To avoid H₂S rising up throughout the internal compartments of the transition piece, the foundation design included an airtight platform

A ventilation system was designed to allow passive removal of any H_2S : a ventilation pipe was installed that connected the moonpool compartment to the open environment above sea level so gasses could passively escape the moonpool.

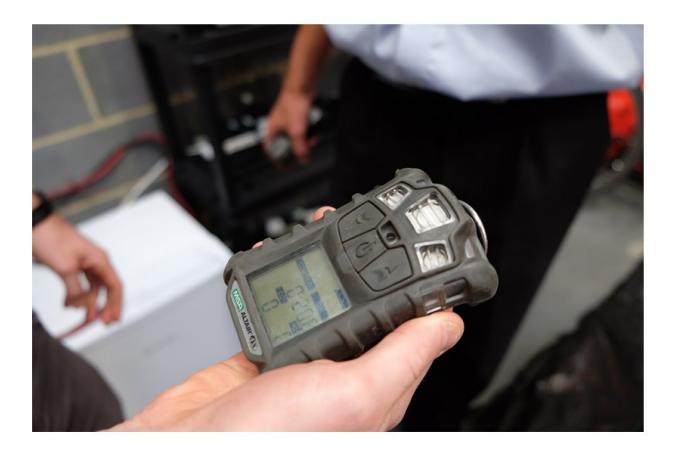
Figure 4: a personal H₂S monitor

All staff, including EDF-ER and the turbine manufacturer's technicians, were equipped with personal H_2S monitors, as illustrated in Figure 4, and instructed that any activity on a turbine was to be stopped and all personnel to transfer off the turbine if levels of H_2S exceeded 1ppm.

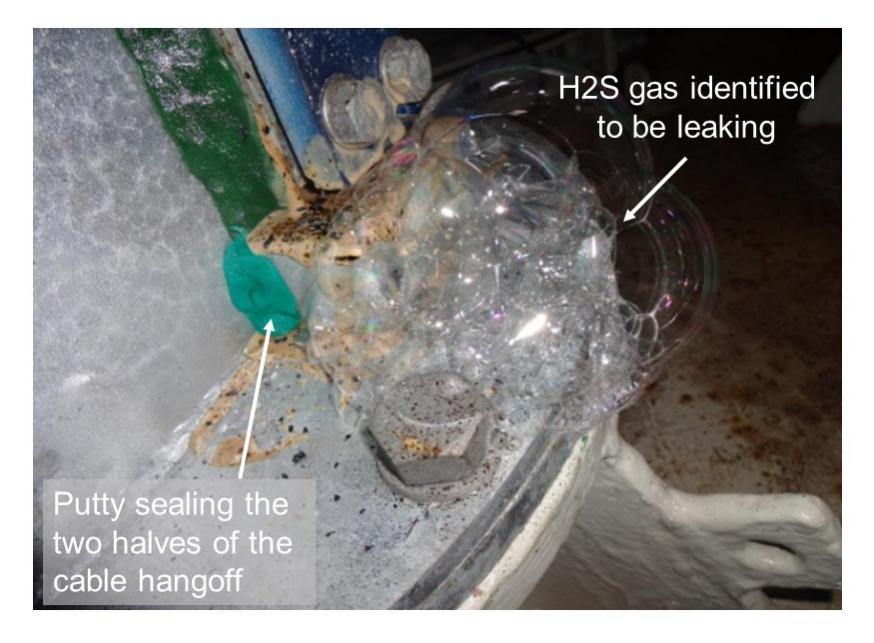
Figure 5: Leak detection spray used to identify leaks in the cable hang-offs on the airtight platform

A leak detection spray was deployed on the airtight platform to identify the source of any leaks. This essentially coats the area to be investigated in a soapy solution so escaping gas can be spotted when air is blown into the moonpool through the ventilation system. It was clear that gas was escaping through the cable hang-offs on the airtight platform, as Figure 5 shows:

The investigation concluded that the modular design of the hang-off structure was flawed. The hang-off consists of two steel structures with a sealant between any surface interfaces and the EDF-ER operations team found that the sealant between the two was incorrectly applied, causing leaks in the system.

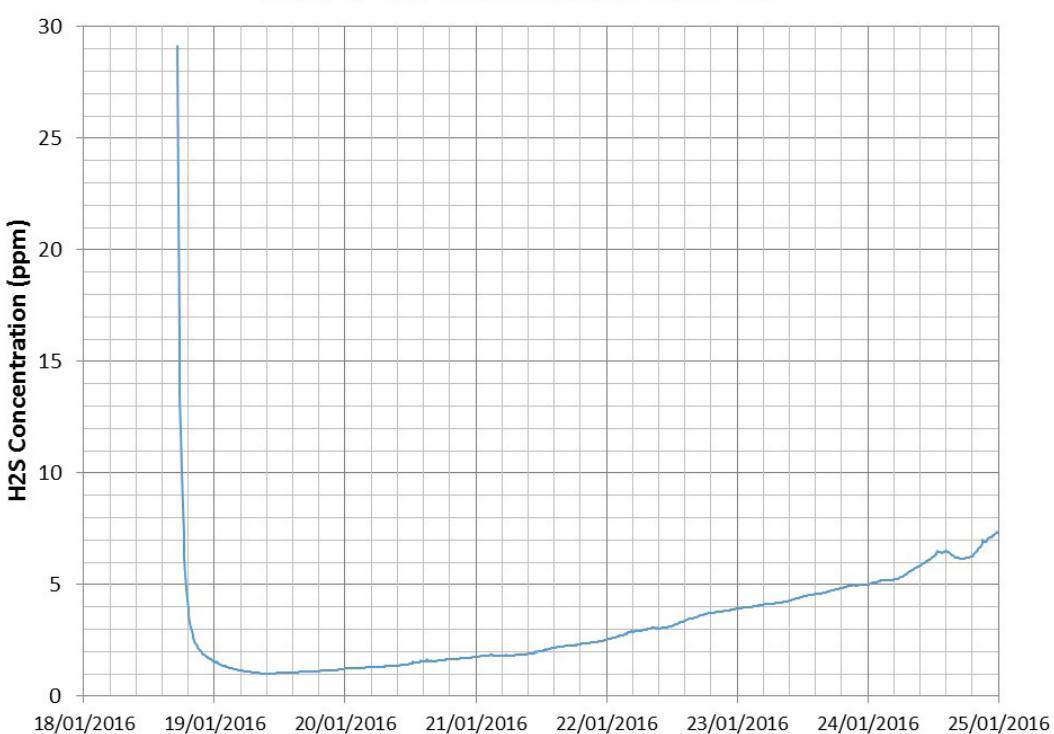
Figure 9: Example of monitored levels of H2S in WTG13 at Teesside offshore wind farm over a one-week period

Data collected recently from WTG13, which had a non-drilled monopile with string anodes and a Tekmar seal, is presented in Figure 9.

A fixed H_2S monitor was located in the moonpool area which is below the airtight platform within the transition piece. This chart shows how the concentration of H_2S varies over a period of one week.

The results from 19 January 2016 indicate that forced ventilation is clearly very effective at reducing levels of H_2S , however across the subsequent six days, the concentration steadily builds up to a hazardous level.

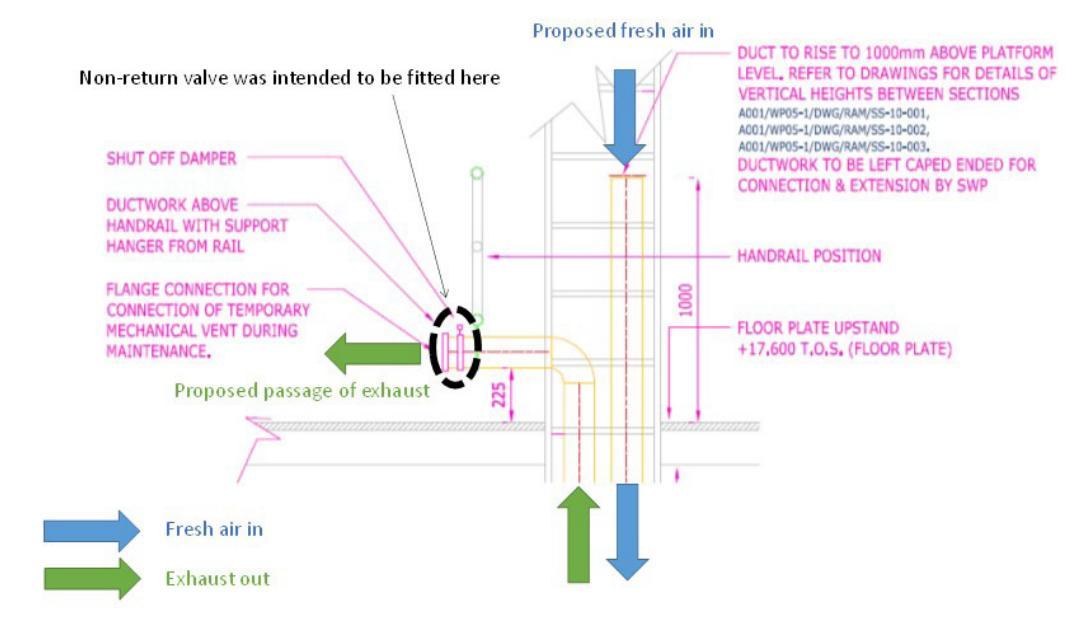
Figure 10: Proposed tixed ventilation system under normal day-to-day operation

The system included two pipes passing through the airtight platform, one connecting the moonpool to the coolant level of the transition piece to allow fresh air into the moonpool and the other pipe connecting the moonpool to the external atmosphere to allow exhausts to escape. The original design was modified to prevent flow from below the airtight platform returning inside the tower. This was effected by replacing the shut off damper at the outlet connecting to the external atmosphere with a non-return valve, as illustrated in Figure 10.

However, this non-return valve was never installed and air was able to enter the substructure via this pipe. This added to the existing problem of the leaking hang-offs and more H_2S was forced up through the transition piece.
